Damp, Timber & Mould Survey Report

Residential Damp, Timber & Mould Inspection Report

24 Example Avenue, Example Town

Report Ref: FBD95C2E

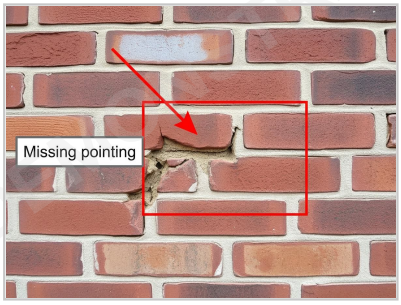
Localised areas of missing and recessed pointing were observed to the front elevation, most notably at the head of the bay window and to the return of the main entrance reveal. Mortar loss is up to approximately 20 mm deep in the worst affected joint (photographed). The exposed bed and perpend joints are acting as a direct rainwater ingress path to the outer leaf. The pattern of defective pointing correlates spatially with the internal penetrating damp identified to the front bedroom, and repair is recommended as a priority.

Figure 2 — Pointing & Mortar Joints (Missing pointing to front elevation adjacent to bay window head — direct rainwater ingress path)

1. Renew perimeter mastic seal to the external window frame using a low-modulus silicone sealant.
2. Rake out and repoint the affected areas of the front elevation with a lime-based mortar matching the existing (see external observations).
3. Allow the wall a natural drying period of 3–6 months before any replastering; take confirmatory moisture readings before internal reinstatement.
4. Install trickle vents to the window head to improve background ventilation and reduce surface condensation risk on the same wall during colder months.

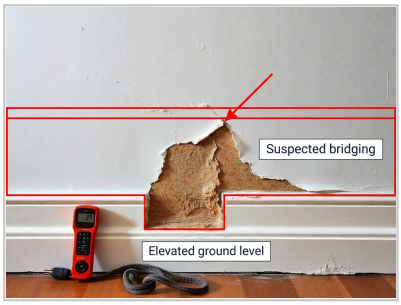
Observation
Localised moisture ingress identified to the lower 750 mm of the rear external wall, most pronounced to the left of the chimney breast where the highest moisture reading in the survey (27 %WME) was recorded. Decorative finishes are lifting and salt bloom is present at the surface of the plaster, indicating repeated wetting and drying over a sustained period. Moisture readings fall sharply above 600 mm and reach background levels by 1 m, which is not typical of true capillary rising damp and instead supports lateral ingress. The pattern is consistent with the externally observed bridged DPC (patio slabs +65 mm above DPC) and the ongoing gutter overflow directly above. Skirting timber was elevated (22 %WME) but sound on probing — no active decay identified. Rectangle annotation on the referenced tide-mark photograph frames the primary affected zone; arrow indicates the height at which readings return to background.

Figure 3 — Rear Reception Room (Rear reception external wall — localised low-level moisture ingress, salt bloom and plaster loss; meter shown for scale)

1. PENETRATING DAMP — REAR RECEPTION ROOM (High risk)
- Maximum reading 27 %WME at base of rear external wall
- Moisture profile drops sharply with height — lateral ingress, not true rising damp
- Bridged DPC (patio +65 mm above DPC) and leaking rear gutter outlet identified as external sources
- Skirting elevated (22 %WME) but no active decay
Evidence: Figure 3, Rear Reception Room moisture profile, Ground Levels & DPC and Rainwater Goods observations.

Address the external moisture sources before any internal remediation is undertaken:

1. Lower external ground level at rear so that the finished paving sits a minimum of 150 mm below the visible DPC, or install a compliant cavity tray / physical separation.
2. Repair or renew the defective rear gutter outlet identified in the external observations.

Once external repairs are complete, allow a monitoring period (recommended minimum 3 months across a range of weather conditions) with repeat moisture readings before committing to internal replastering. If readings remain elevated after external works, hack off affected plaster to 300 mm above the highest damp reading and reinstate with an appropriate renovating plaster system. Chemical DPC injection is not recommended at this stage because the evidence points to lateral bridging rather than capillary rising damp, and treating the wrong mechanism will not resolve the issue.

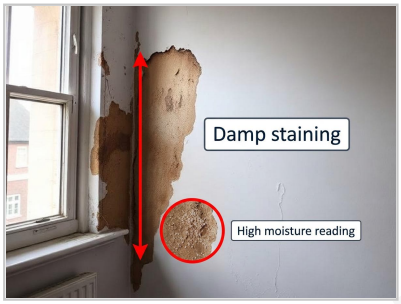
Penetrating damp to the external wall adjacent to the front bay window. Active water tracking is visible from the window reveal downwards, with soft, blown plaster to a maximum extent of approximately 900 mm below the cill. Adjacent internal partition wall recorded a control reading of 12 %WME, confirming that elevated readings are confined to the external wall only. The pattern of ingress directly beneath the externally observed missing pointing at the bay window head strongly supports rainwater penetration through the outer leaf as the primary mechanism. Failed mastic to the window frame is a secondary contributor. No evidence of interstitial condensation or plumbing origin was found. Annotations on the referenced photograph identify the extent of the damp staining and the point at which the highest moisture reading was taken.

Figure 4 — Front Bedroom (Front bedroom external wall adjacent to window — active damp staining and blown plaster)

2. PENETRATING DAMP — FRONT BEDROOM (High risk)
- Active water tracking beneath bay window; control reading on adjacent partition confirms localisation
- Directly beneath externally observed missing pointing to bay window head
- Failed perimeter mastic a secondary contributor
Evidence: Figure 4, Front Bedroom findings and Pointing & Mortar Joints observations.

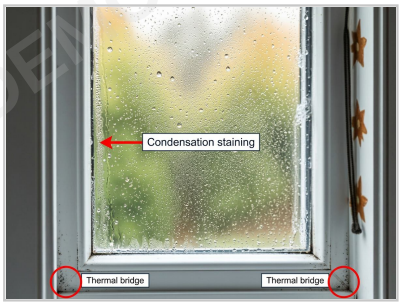
Heavy surface condensation observed to the glazing and to the perimeter of the window frame. Water was streaming down the glass and pooling on the timber cill (18 %WME) at the time of inspection. Minor early-stage surface contamination is present at the internal frame corners. The cooker hood was tested and found to recirculate internally rather than duct to external air; no other mechanical extraction is present in the kitchen. Meter readings elsewhere in the room are within normal range — no evidence of a plumbing leak or penetrating source. The mechanism is condensation driven by moisture generation from cooking combined with the absence of compliant mechanical extraction. Annotations on the referenced photograph identify the condensation streaming and thermal-bridge frame corners.

Figure 6 — Kitchen (Kitchen window with heavy surface condensation and thermal-bridge frame corners)

1. Install mechanical extract ventilation with reference to Approved Document F guidance for new intermittent kitchen extract fans (30 l/s adjacent to the hob or 60 l/s if remotely located; other system types use different rates), with confirmed ducted discharge to external air.
2. Modify the existing cooker hood to discharge externally rather than recirculate internally, or replace with an externally-vented unit.
3. Restore or install operational trickle ventilation to the window.
4. Provide occupant guidance: keep the hob extractor running during and for 10 minutes after cooking; keep the kitchen door closed during cooking to contain moisture generation.
